SKATE PARK SAFETY INSPECTION REPORT

North Hinksey Parish Council

21st September 2009

Report to North Hinksey Parish Council following a site visit to inspect a fire damaged concrete skate bowl Monday 21st September 2009

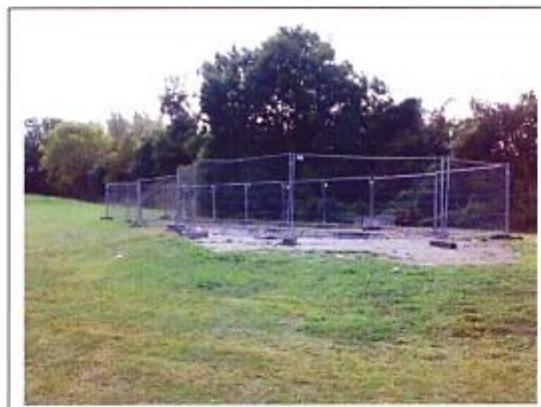
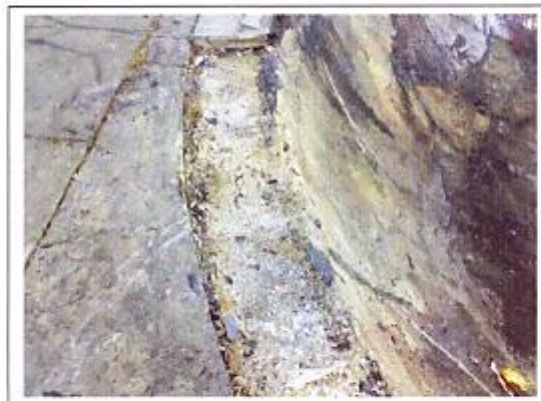
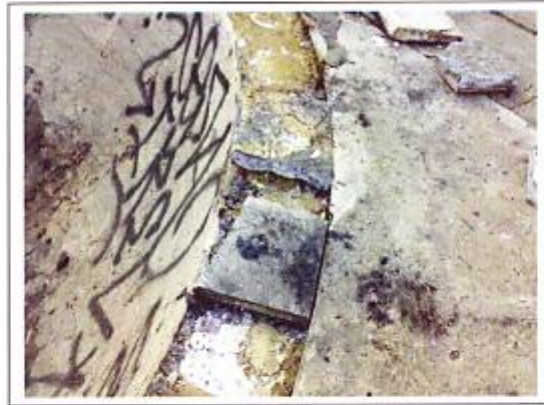
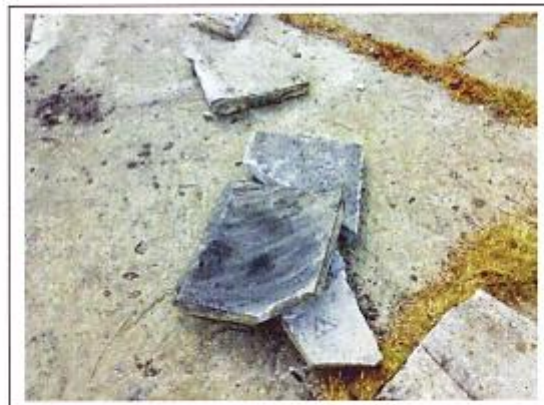
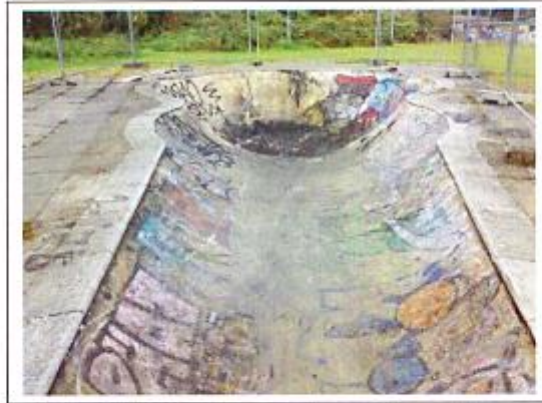
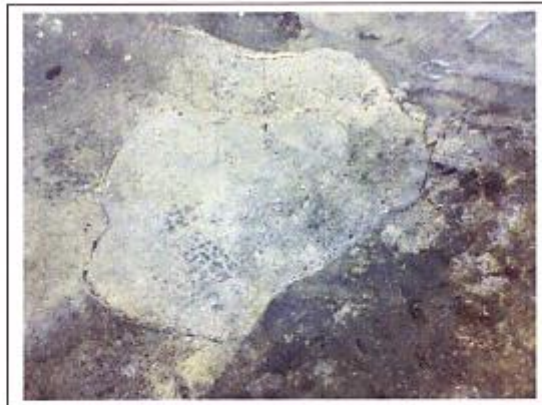
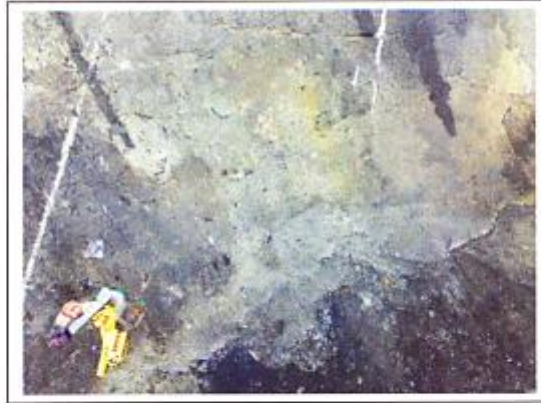
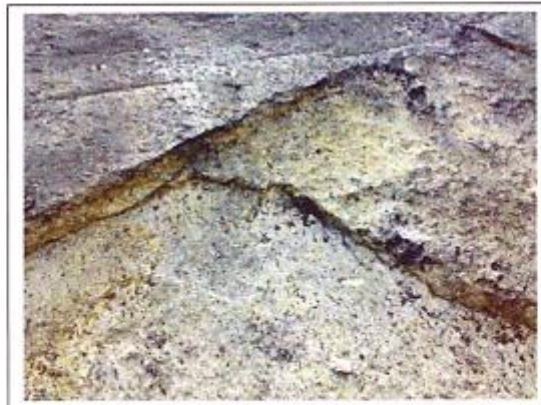
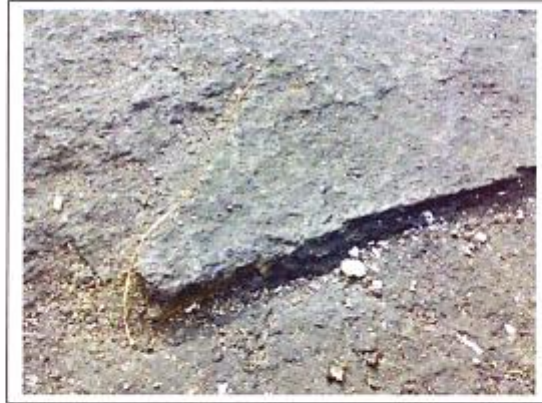
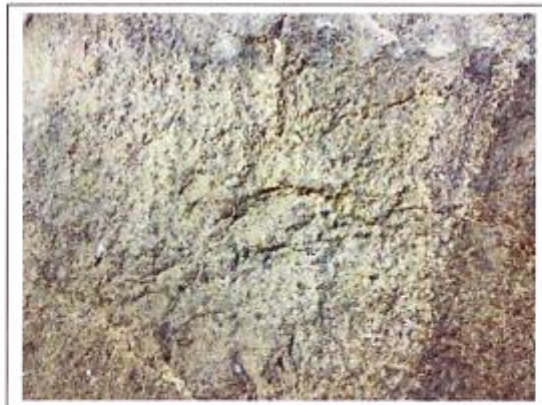
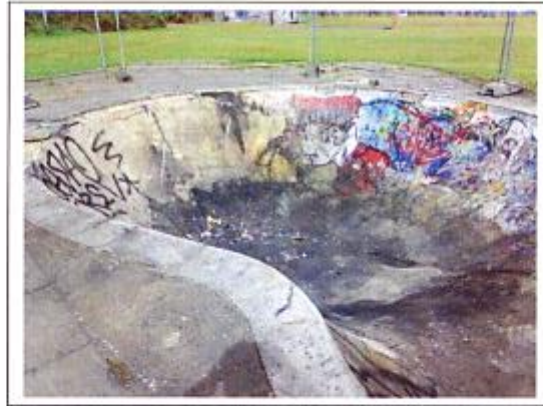
See photographs 6674 – 6684

The fire damaged skate bowl has sustained considerable damage resulting in the riding surface concrete in the actual bowl being substantially damaged and coping stones being cracked, split apart and dislodged. (See attached photographs)

The heat from the vandalism (believed to be a stolen vehicle set on fire having crashed into the bowl – according to young man on site at time of the inspection) was such that the structural integrity of the concrete bowl may have been compromised.

In places the usually smooth, very hard concrete riding surface appears to have “exploded” away from the structure leaving a heavily pitted and rough surface behind. In other places the concrete has lifted completely leaving raised edge and loose, flaking concrete sections. (See attached photographs)

The smooth coping stones usually set in the top of the bowl have become dislodged, fractured and in a number of cases completely broken. Re-instating these coping stones – used by riders to “grind” around the bowl - will require great care and expertise. It is not certain in the Inspector’s view whether or not the stone slabs can be re-installed following such heat and structural damage. (See attached photographs)

There must be a very big question mark over its future and the Inspector recommends a structural survey is undertaken and relevant consultation with the manufacturer/installer to determine future use.

It may be possible to render the damaged surface to create a smooth riding surface and it may be possible to re-instate the grinding edge to the bowl but expert advice will be required and it will undoubtedly not be cheap!
